FIRE RESISTANCE TEST IN ACCORDANCE WITH BS EN 1634-1: 2008

On a Single-acting, Unequal Double-leaf Composite Timber Doorset

Test Report No.: R14D39

Issue Date: 13 August 2014

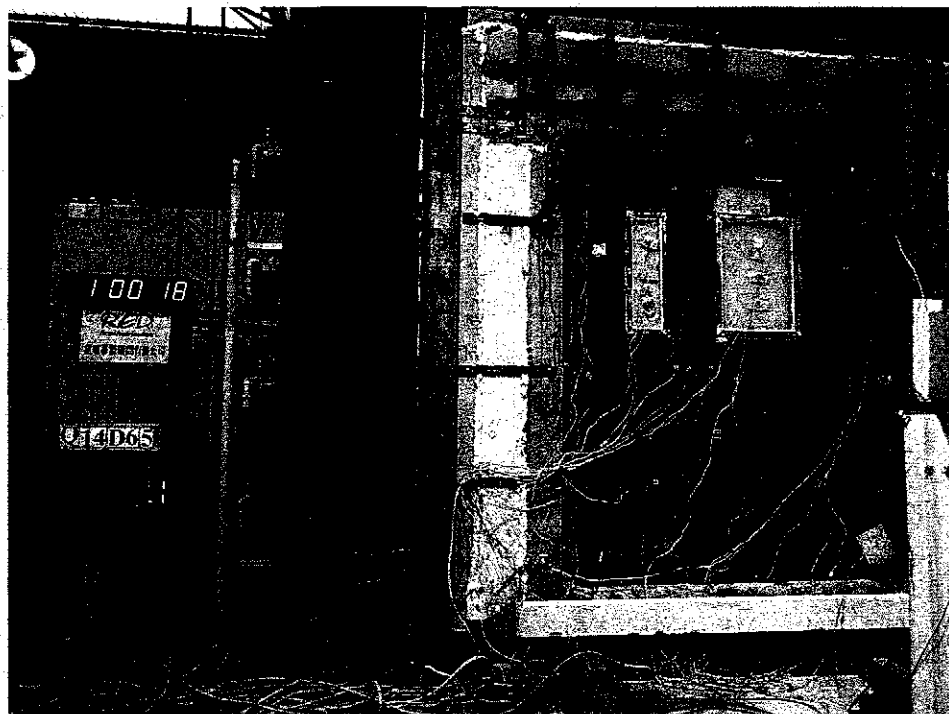
Photo 2: The unexposed face of the specimen after a heating period of 60 minutes.

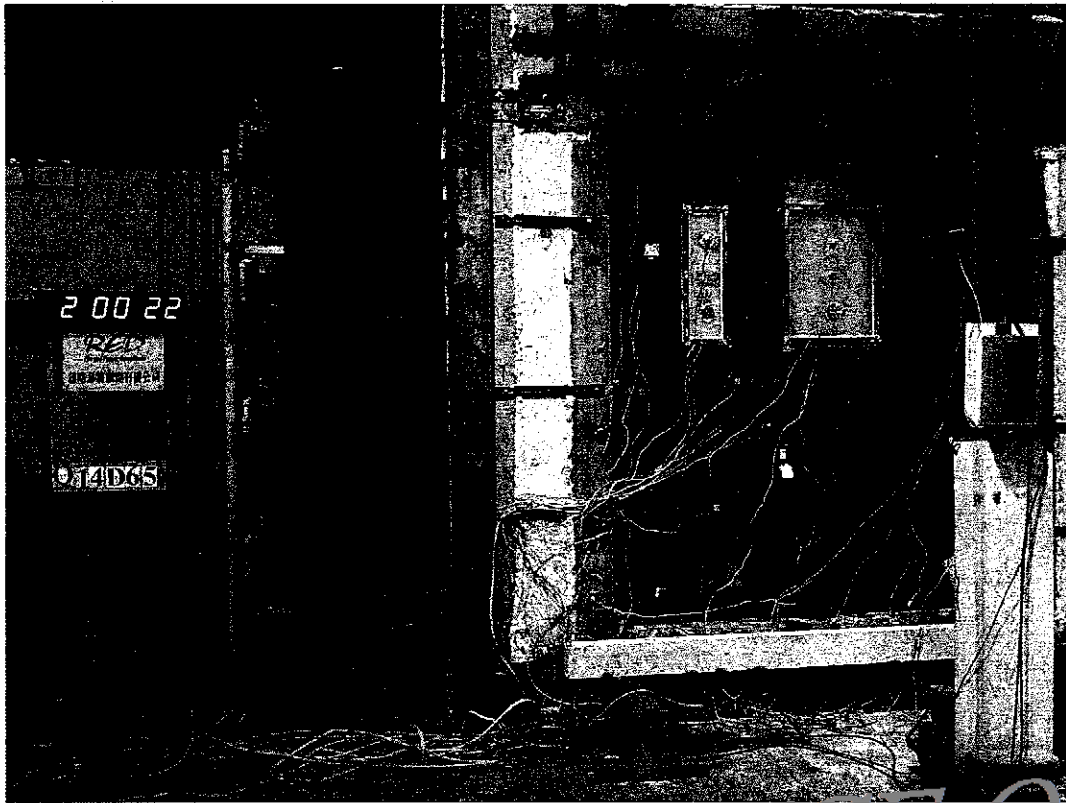
Photo 3: The unexposed face of the specimen after a heating period of 120 minutes.

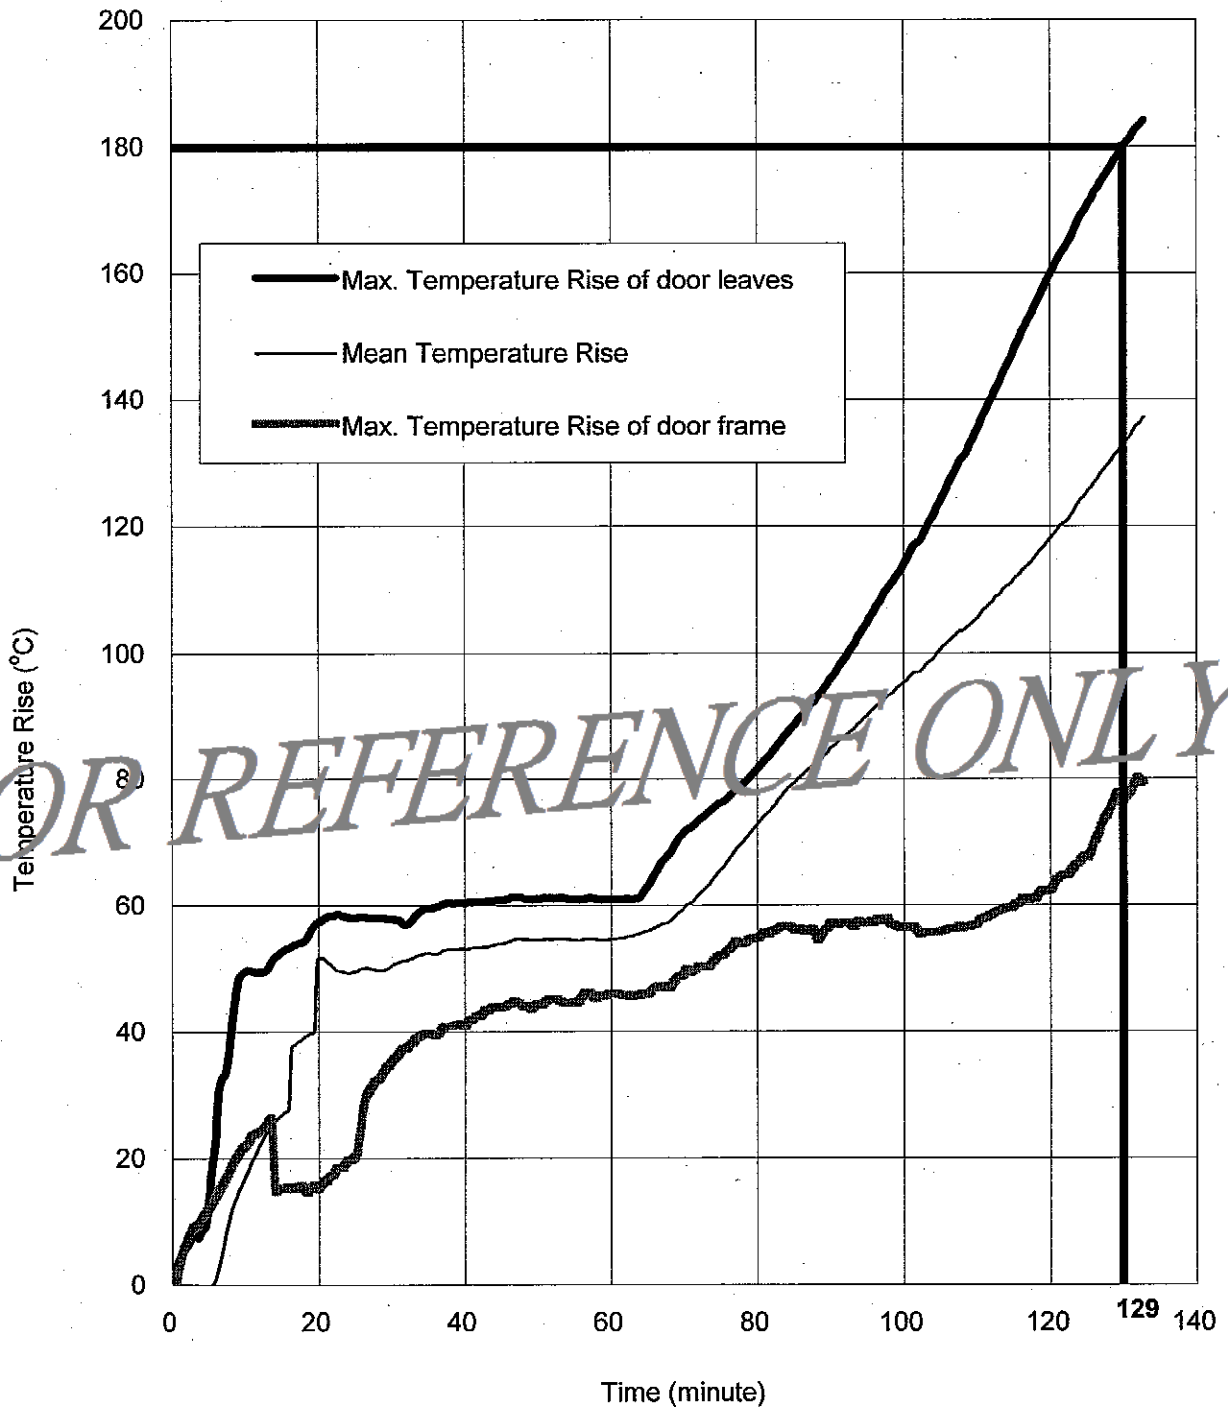
Figure 6 – Temperature rises of unexposed surface of doorset excluding the glazed panel.

The 140 °C rise of the mean temperature of the unexposed surface of specimen did not reach during the test. The 180 °C rise of the maximum temperature of the unexposed surface of specimen reached and measured by thermocouple S9 after a heating period of 129 minutes. The 360 °C rise of the maximum temperature of the unexposed surface of door frame did not reach during the test. The maximum temperature rise was 184 °C measured by thermocouple S9 after a heating period of 132 minutes.

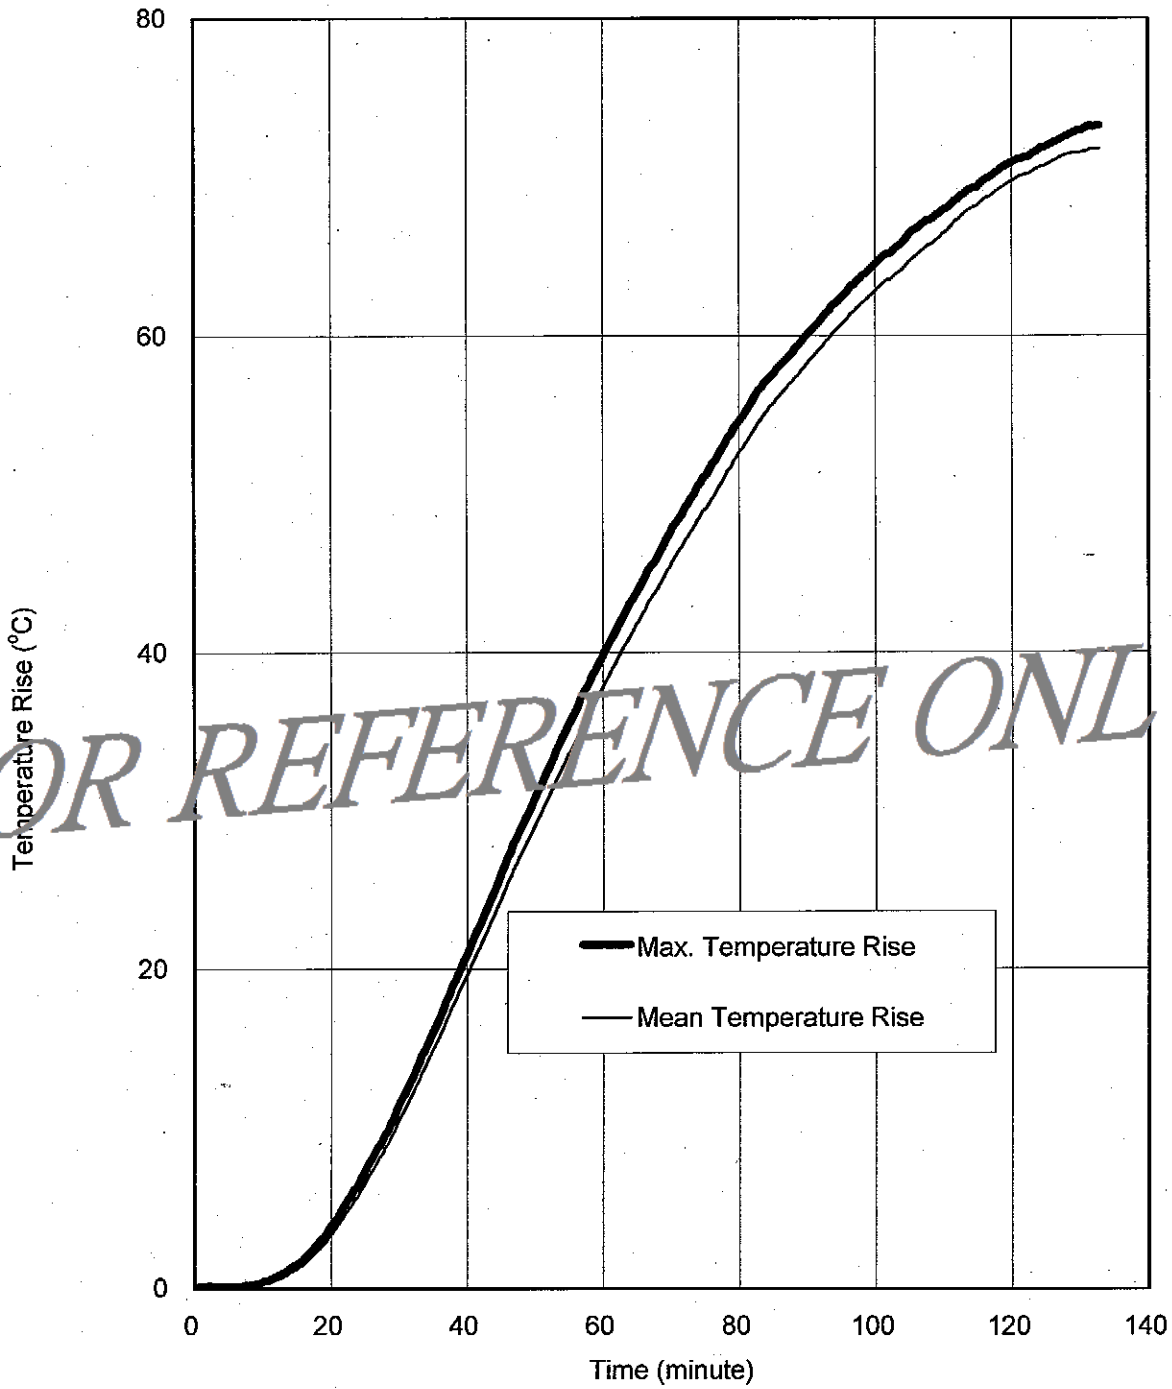
Figure 7 – Temperature rises of unexposed surface of left glazed panel.

The 140 °C rise of the mean temperature of the unexposed surface of left glazed panel did not reach during the test. The 180 °C rise of the maximum temperature of the unexposed surface of left glazed panel did not reach during the test. The maximum temperature rise of the glazed panel was 73 °C measured by thermocouple S29 after a heating period of 132 minutes.
